# DIAGNOSE TIMING CHAIN FAULT

## How to diagnose a timing chain fault in the YD25 D40, D22 Navara & R51 Pathfinder engine.

**This page explains the methods used to diagnose a timing chain fault in the Nissan Navara D40, D22 & Pathfinder R51 YD25 engine.**

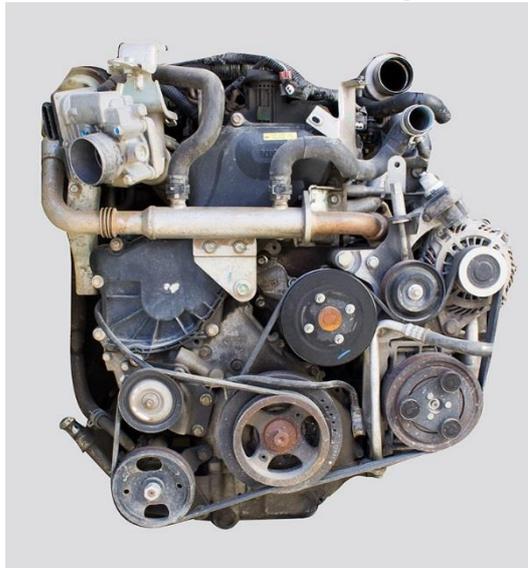
### YD25 engine front view

**Step 1:** Remove the EGR pipe in front of the black cam chain cover.

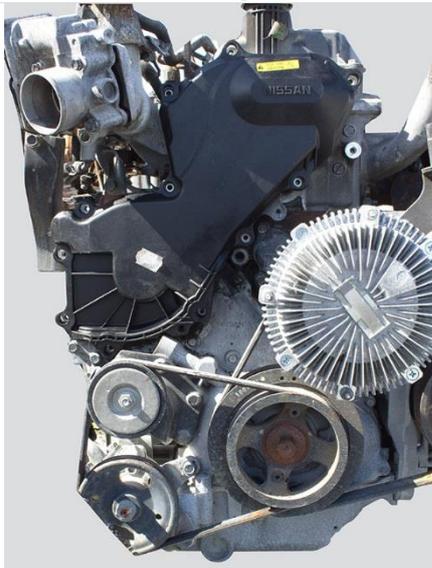
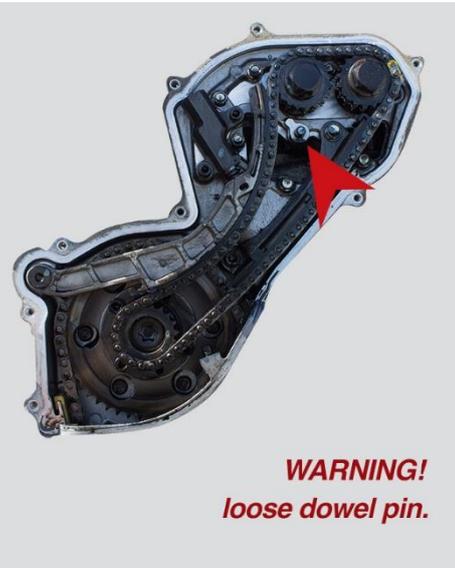
### YD25 engine with EGR pipe removed

**Step 2:** Remove the 10mm bolts securing the black cam chain cover. Remove the cam chain cover taking special care that the alignment dowel does not fall into the sump.

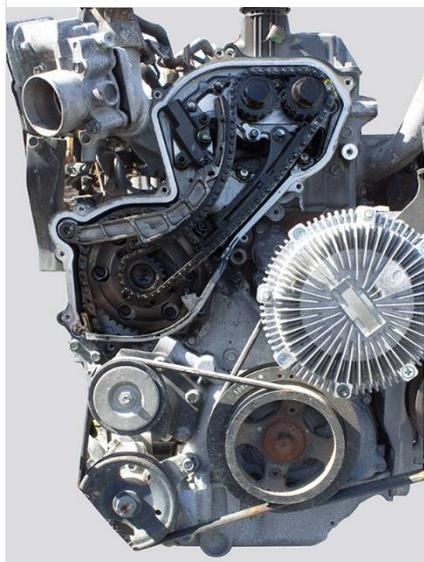
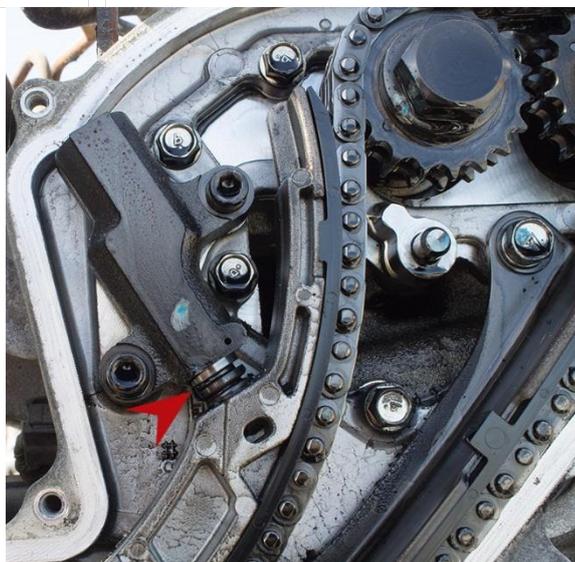
### YD25 engine & exposed cam chain

**Step 3:** Inspect the cam chain tensioner piston protrusion

piston protrusion	chain life
<b>6mm</b>	<b>100%</b>
<b>9mm</b>	<b>75%</b>
<b>12mm</b>	<b>50%</b>
<b>15mm</b>	<b>25%</b>
<b>18mm</b>	<b>worn out</b>

**Step 5:** To check the condition of the camshaft chain tensioner, pull the slack guide back to the tensioner and if it bleeds back quickly then the tensioner has a valve failure and needs replacing. A secondary test can be performed as follows:

1. with the ignition off, remove the injector plug leads
2. while cranking the engine inspect the tensioner piston

The piston must maintain tension on the chain at cranking speed; if the piston moves in and out then the tensioner should be replaced.

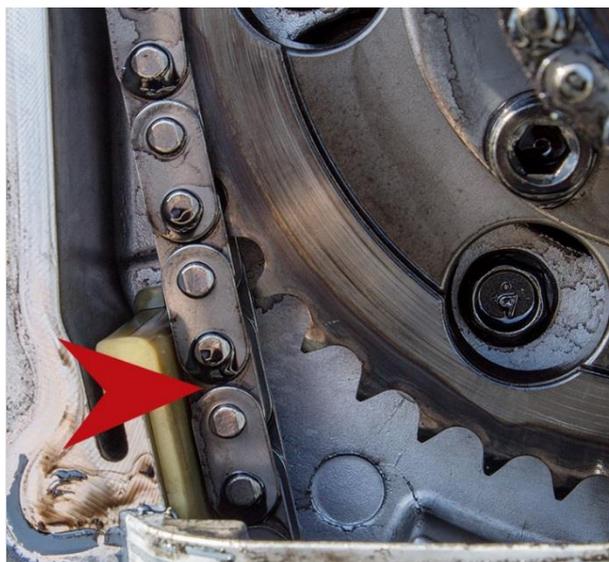
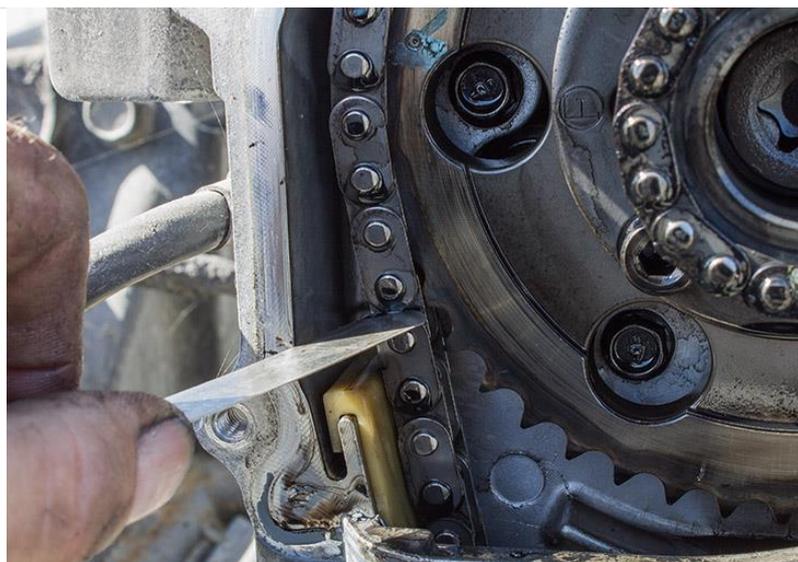
#### **YD25 engine fuel pump drive chain**

**Step 6:** Mark the first link to ensure that every link plate clearance is measured.

**Fuel pump drive timing chain breakage is the major cause of timing chain failures in YD25s. It is essential that you measure every fuel pump drive chain link gap. Do not take short cuts by measuring some links, a badly worn link may be missed and later fails with catastrophic results.**
